Beaches Construction Company

Ocean Towers Column Repairs
2007

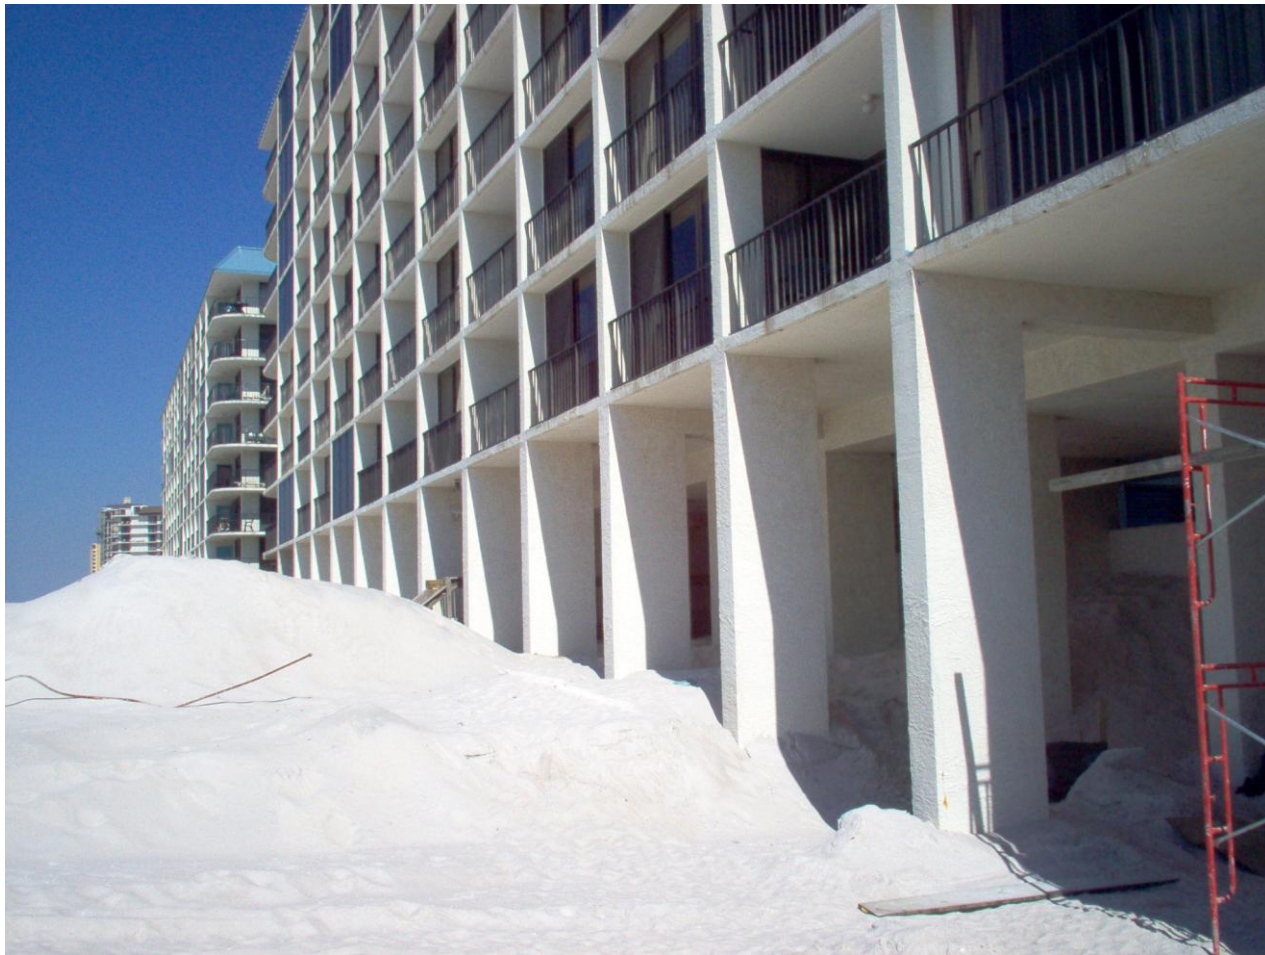
Removal of all sand under building to top of pile cap

Removing 8 feet of sand

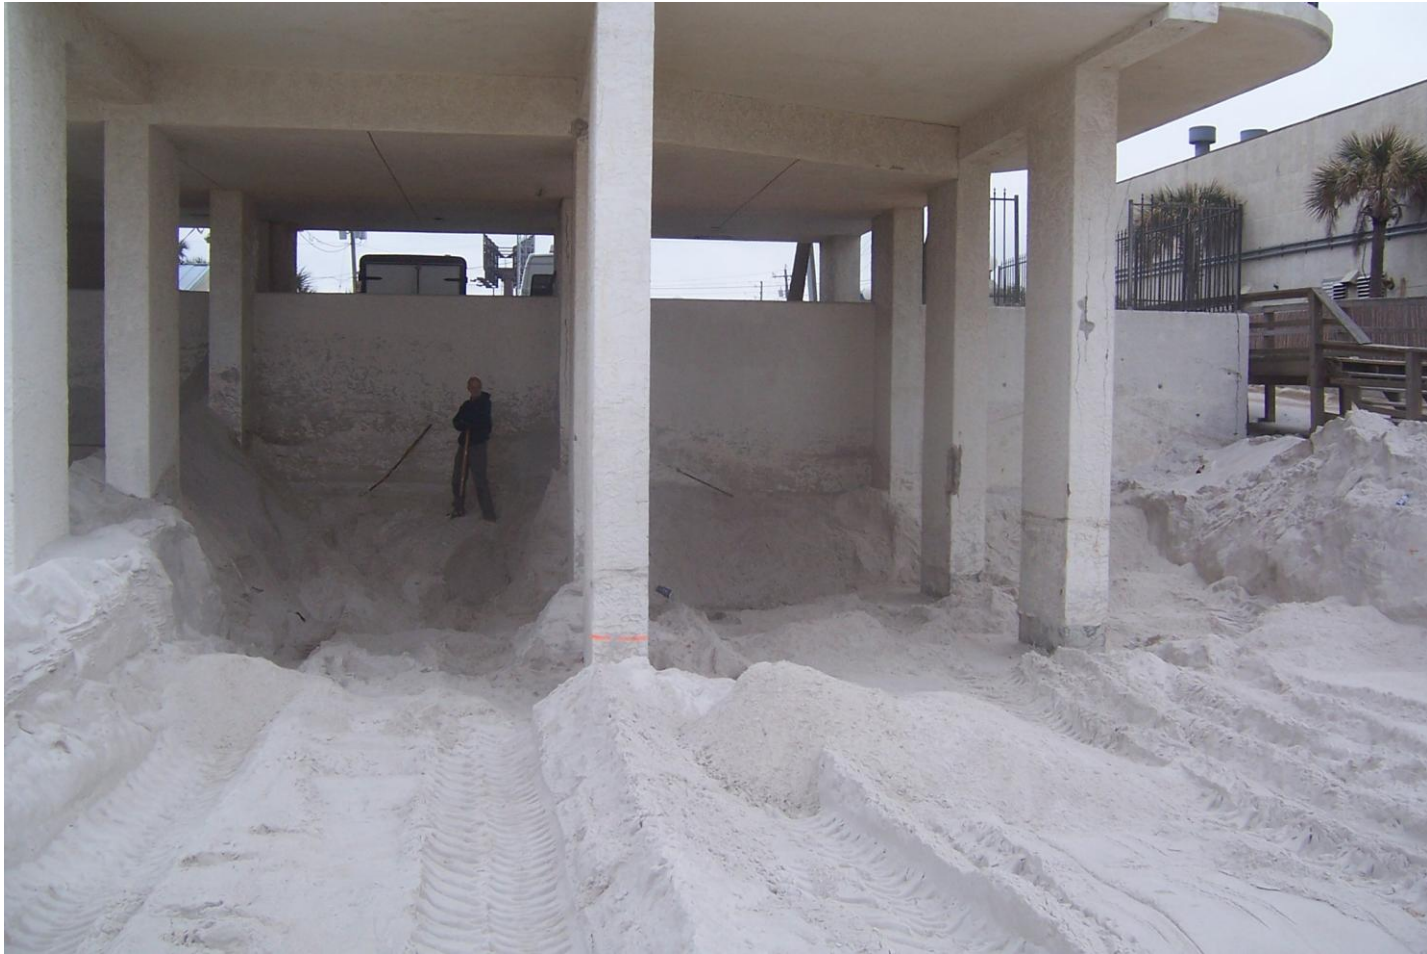
Surveying columns for spalling

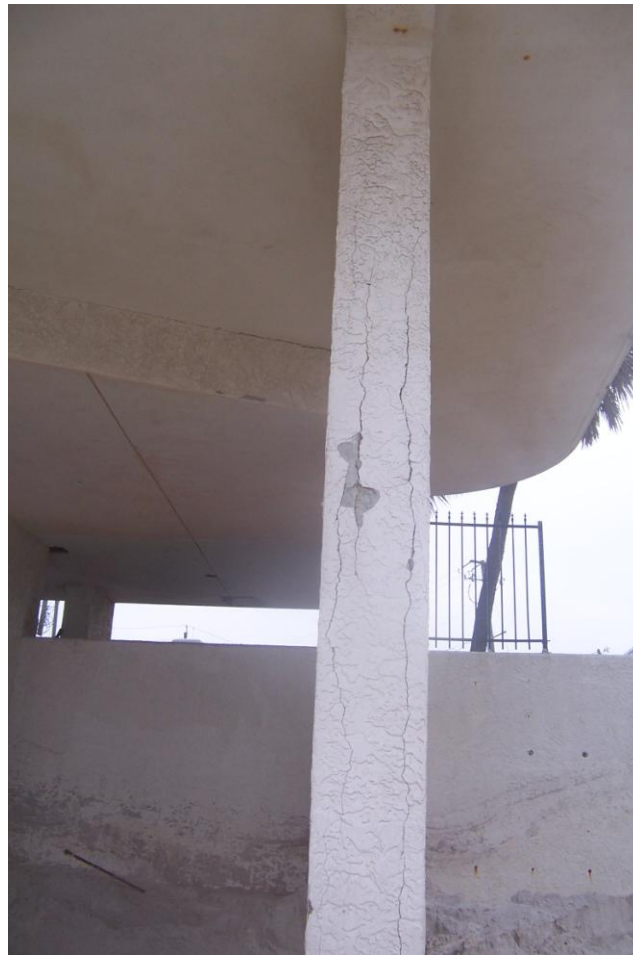
Typical spalling on columns

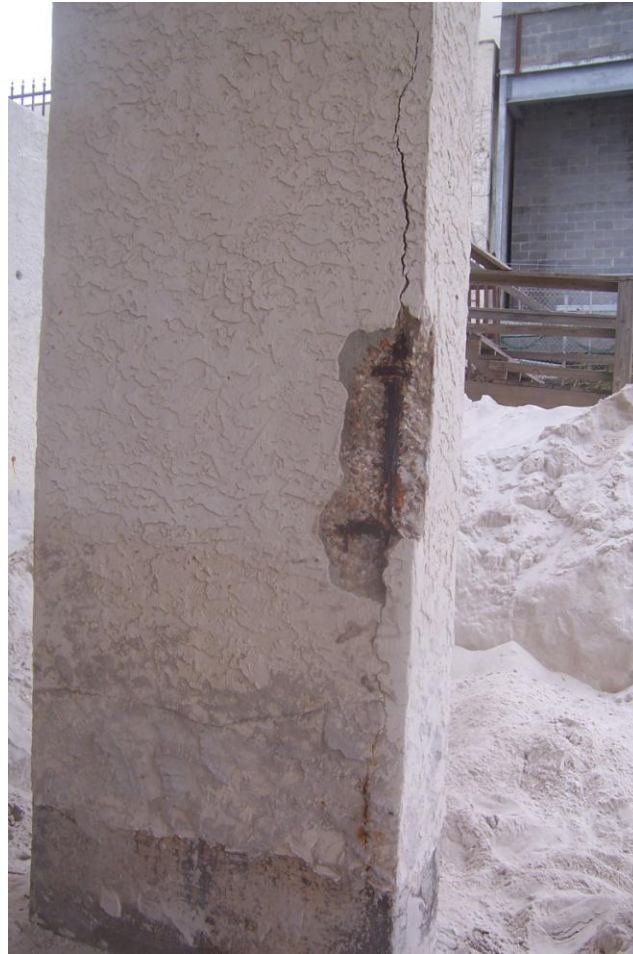
More spalling and damage

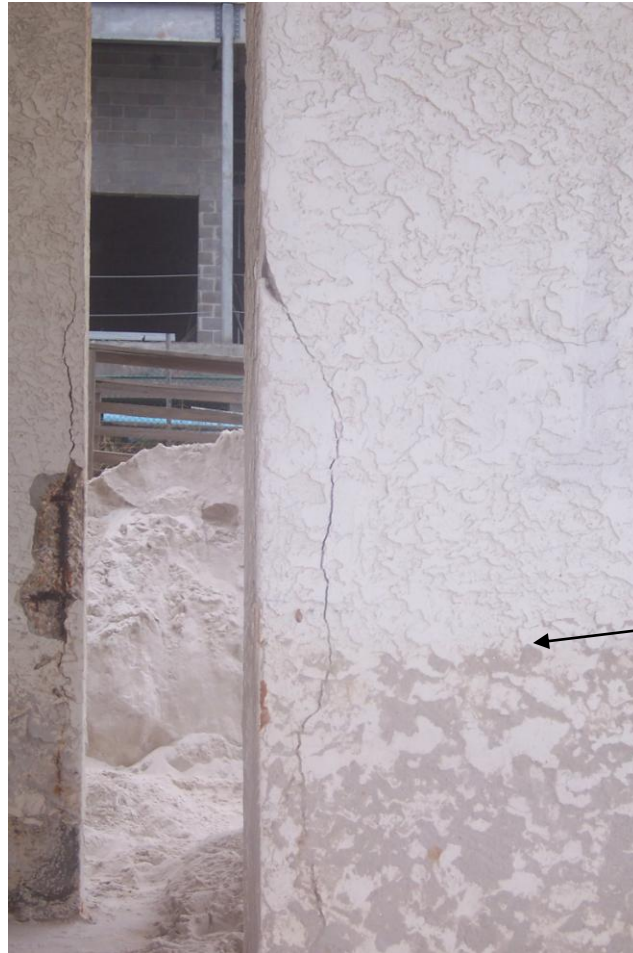
Level of sand prior to removing

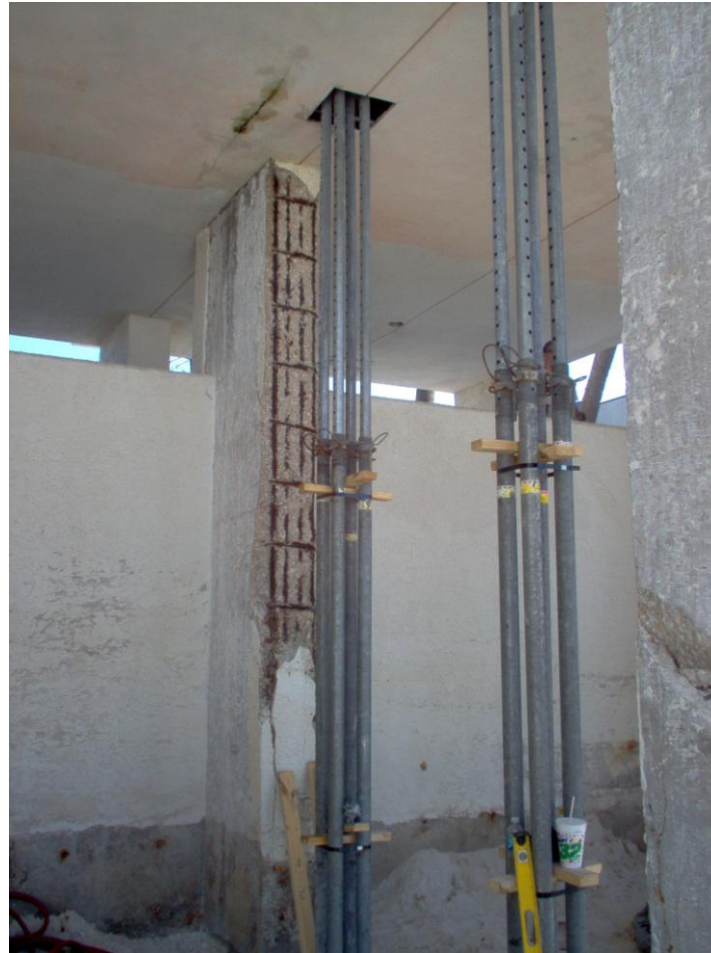
Cut holes in soffitt to reach bottom of beam for shoring

Installing Shoring from pile cap to bottom of beam

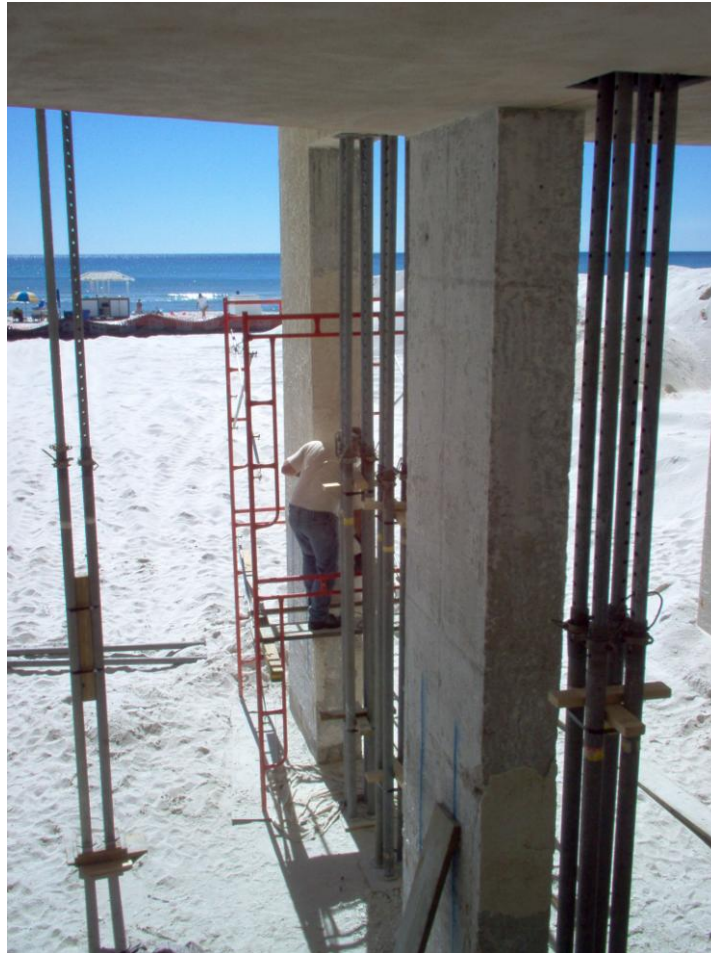
Installing shoring

Shoring in groups of 4 banded together for greater down pressure

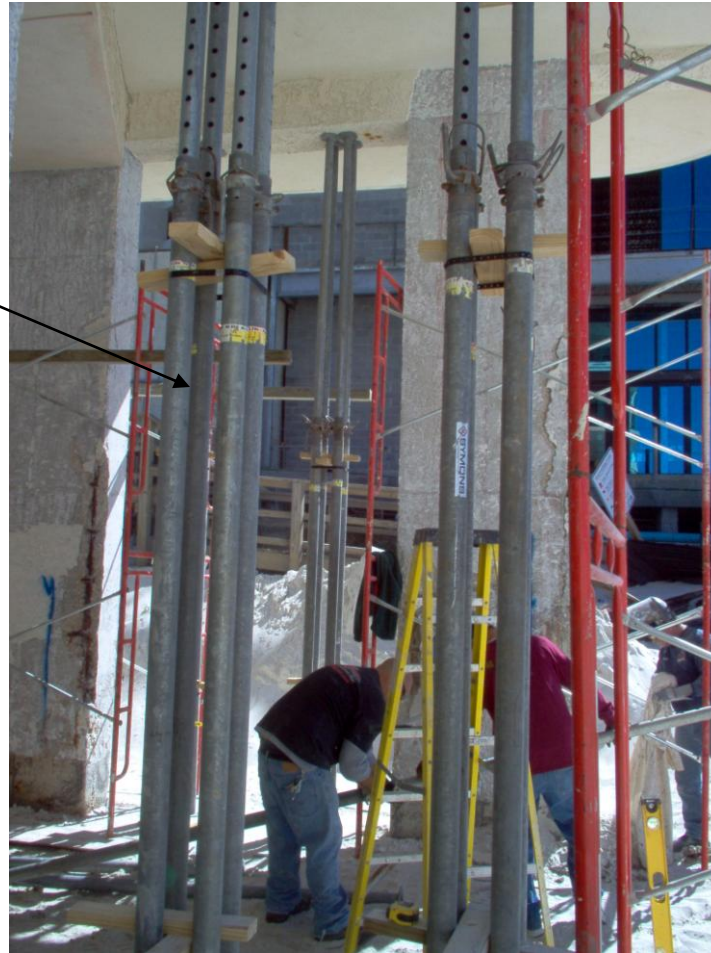
Setting up scaffolding for work platform

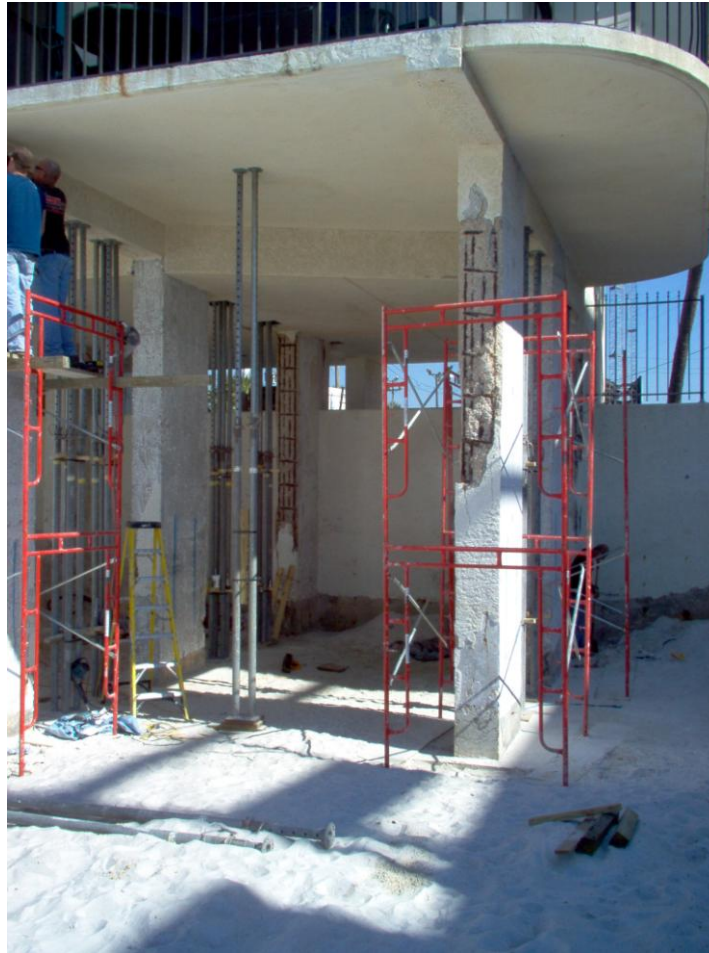
After all stucco is removed we can see the real damage

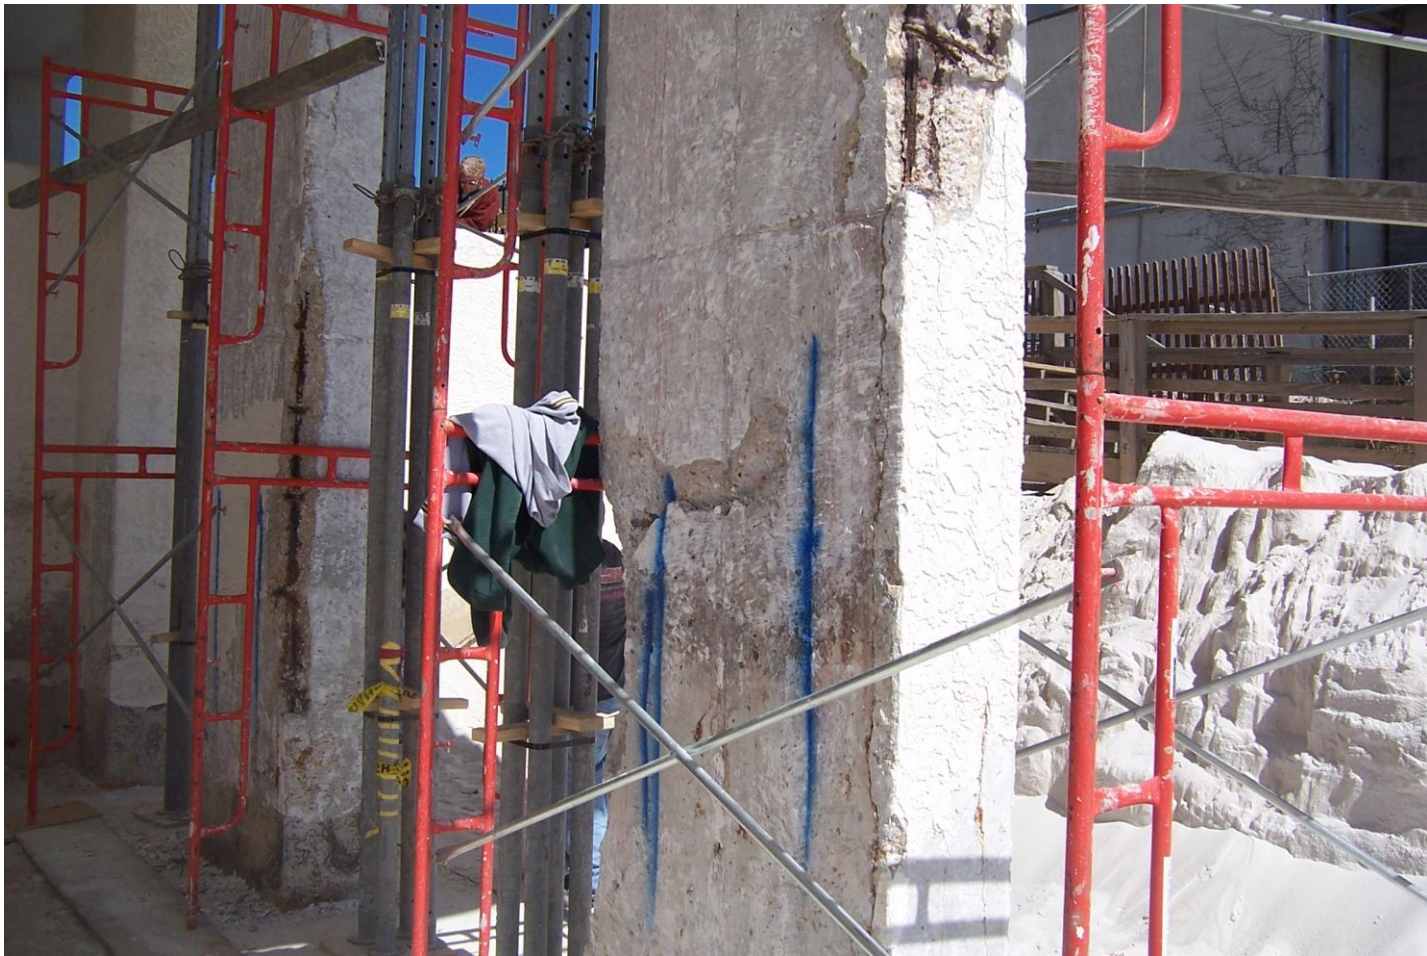
Starting to remove broken concrete with demo hammers

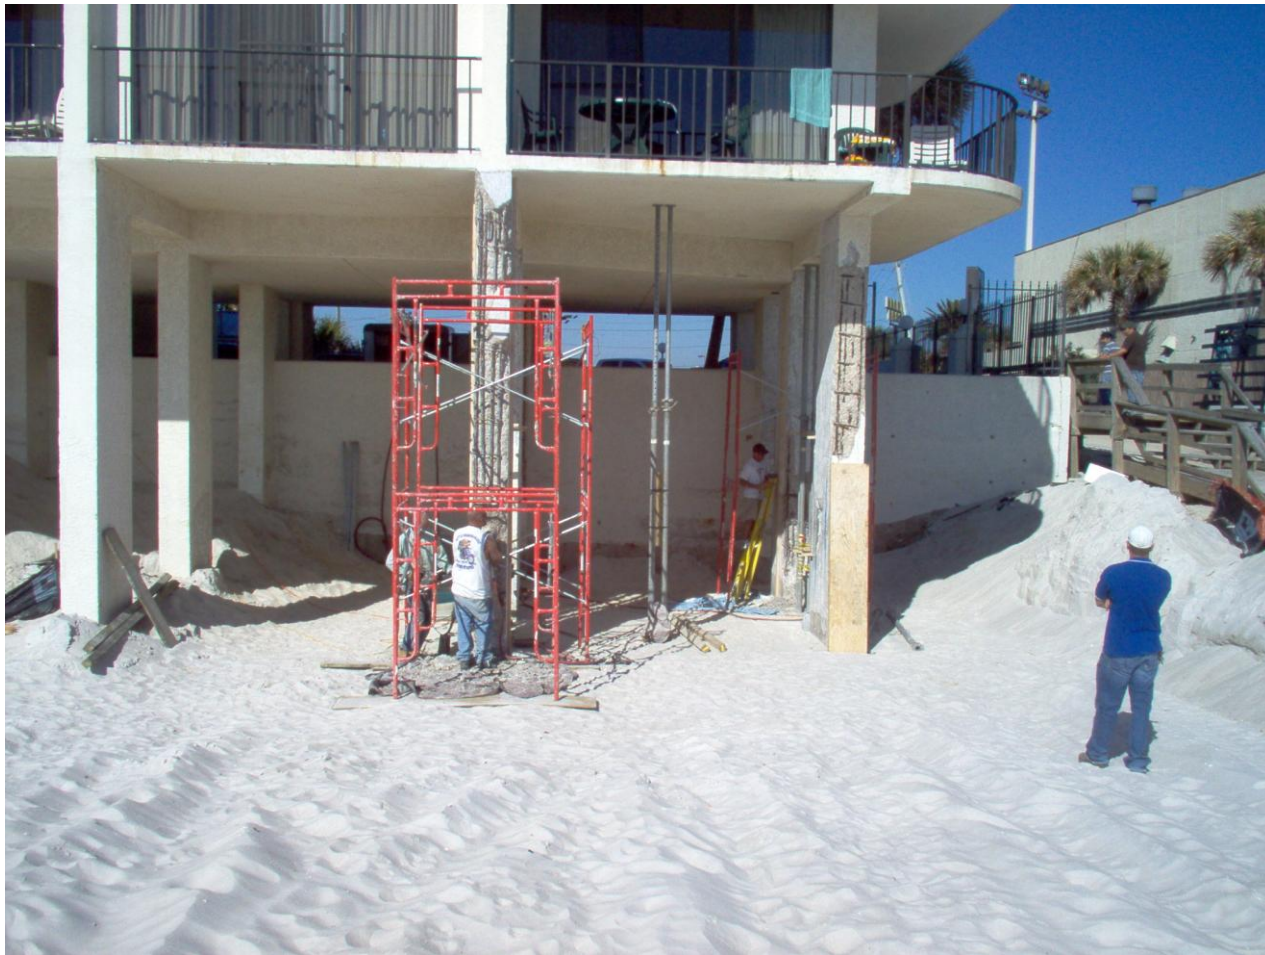
Working on 3 staggered columns at one time to spread load

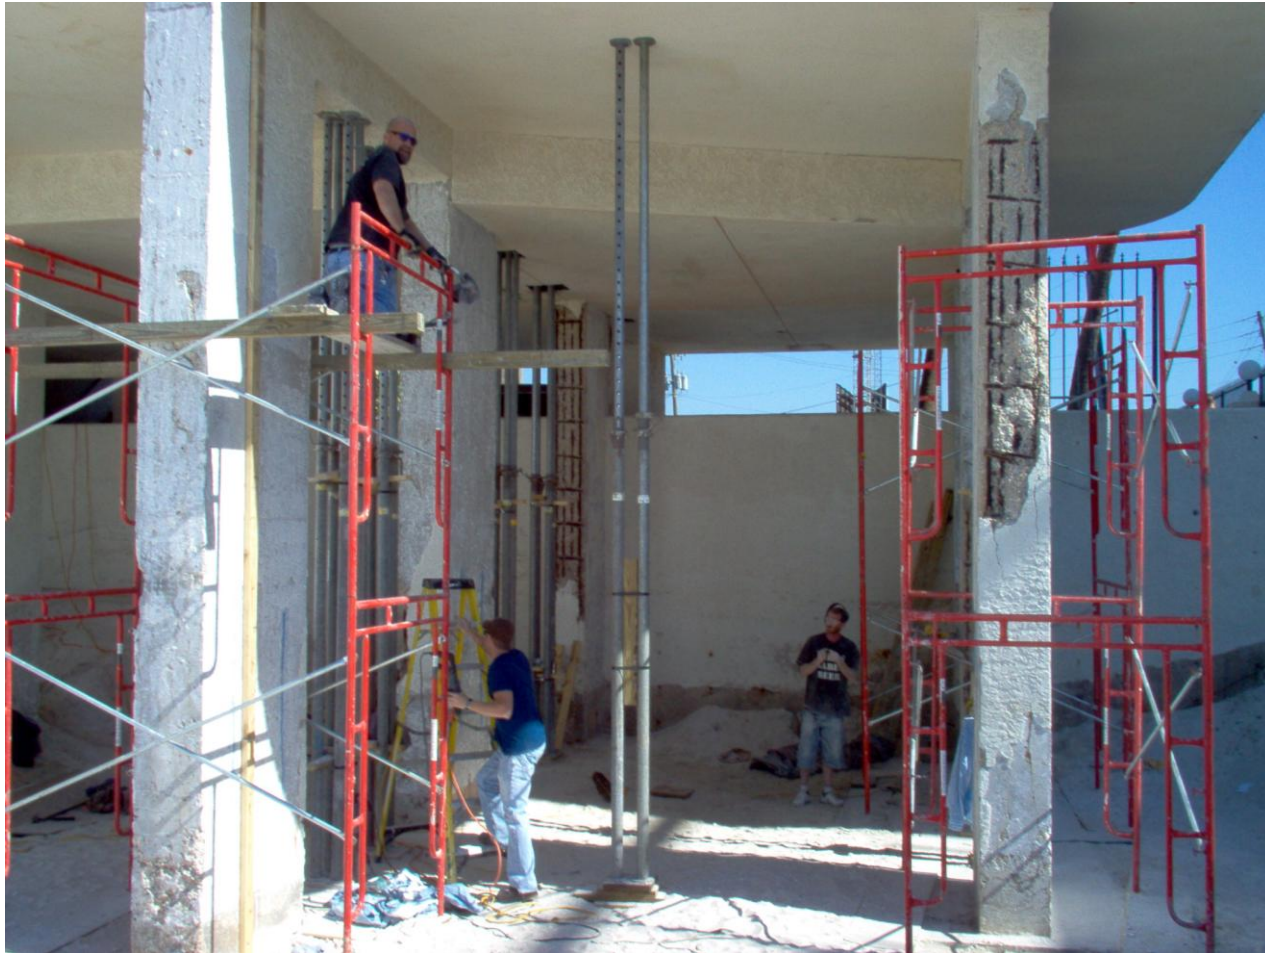
More Demo

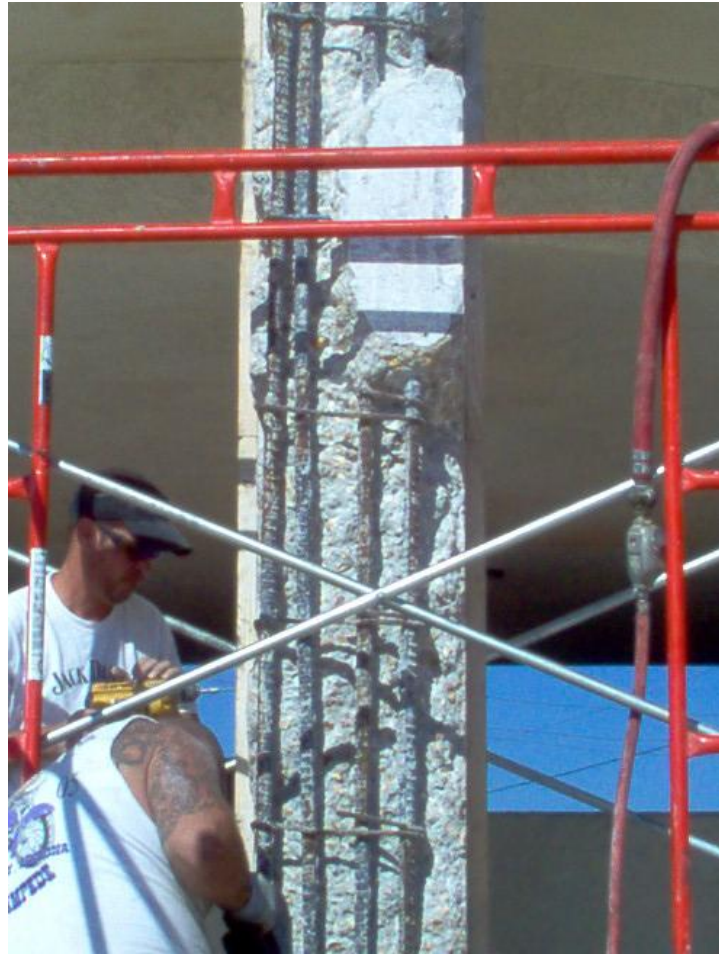
Jack hammer is hard work

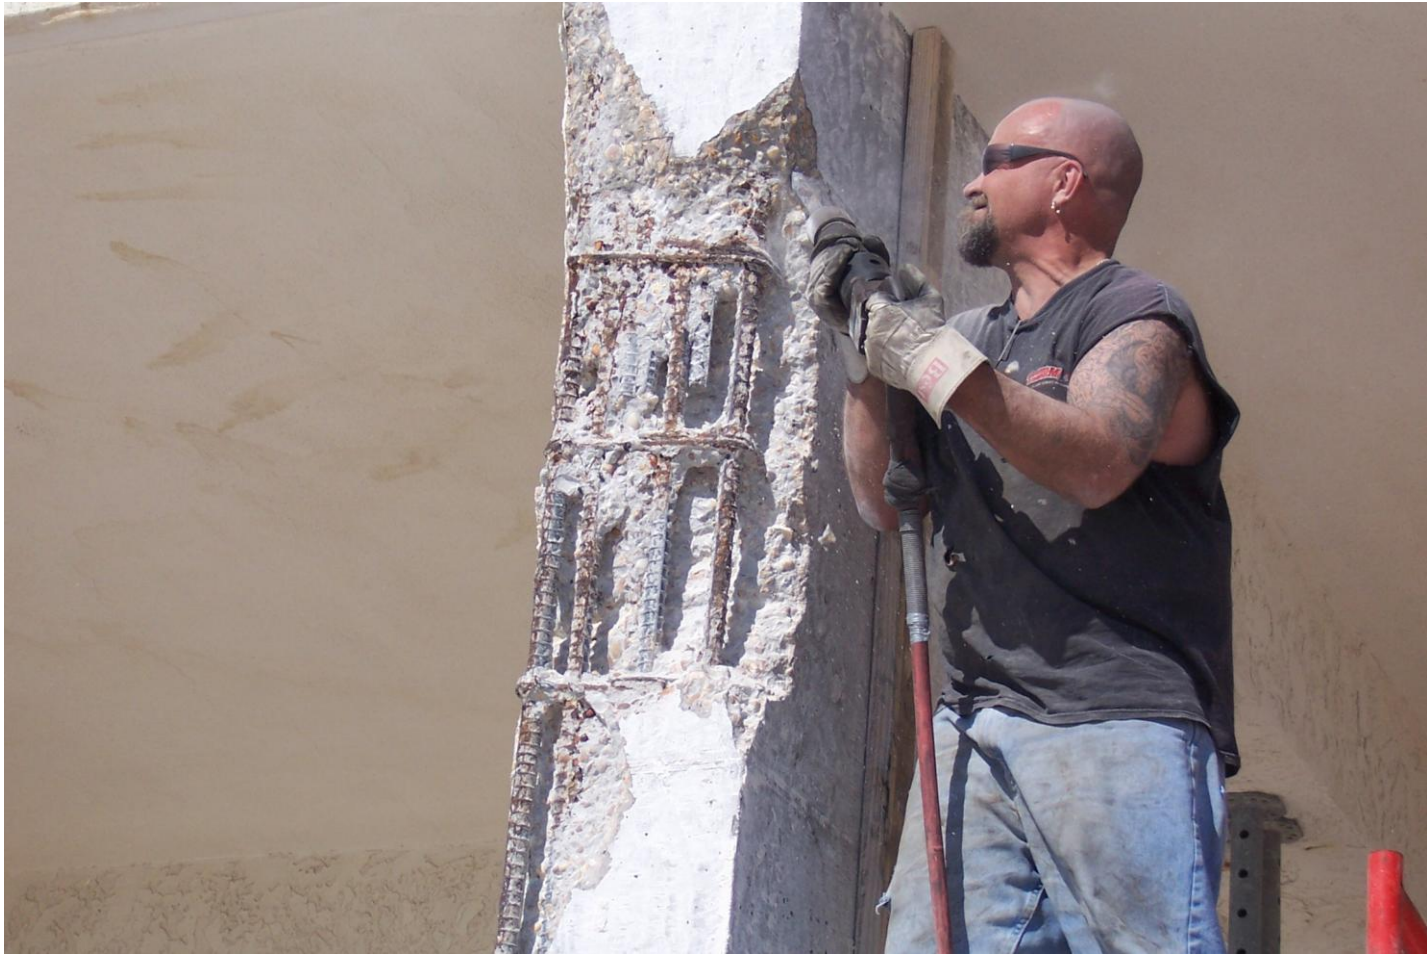
Hard tedious work more demo

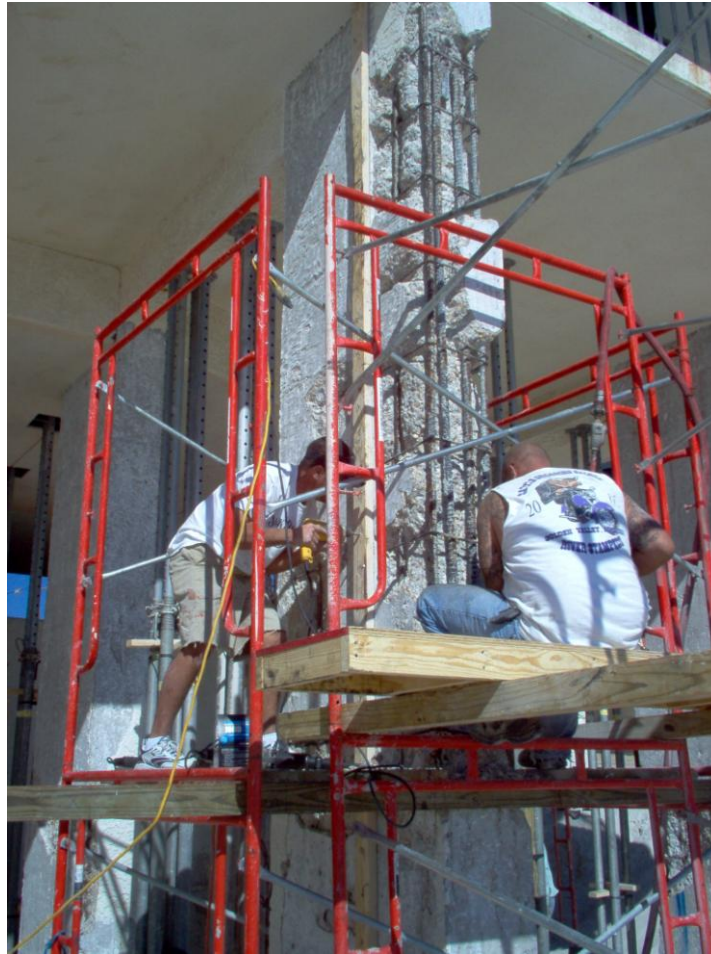
After cleaning of rusted steel a
inorganic zinc coating is applied to
all rebar, field applied galvanizing

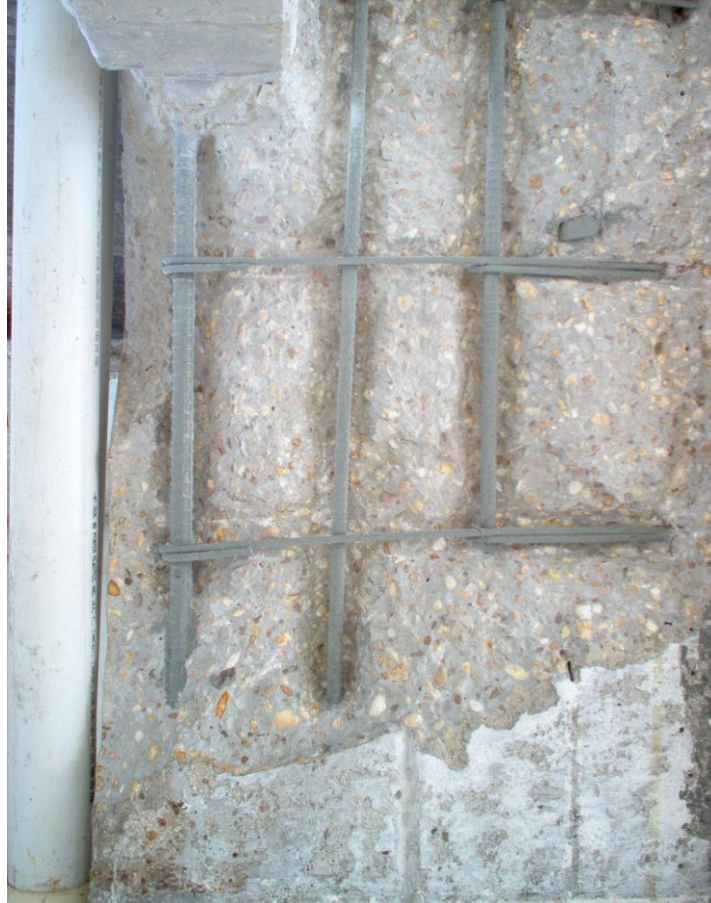
Start to install forming materials

A level is used when installing forms

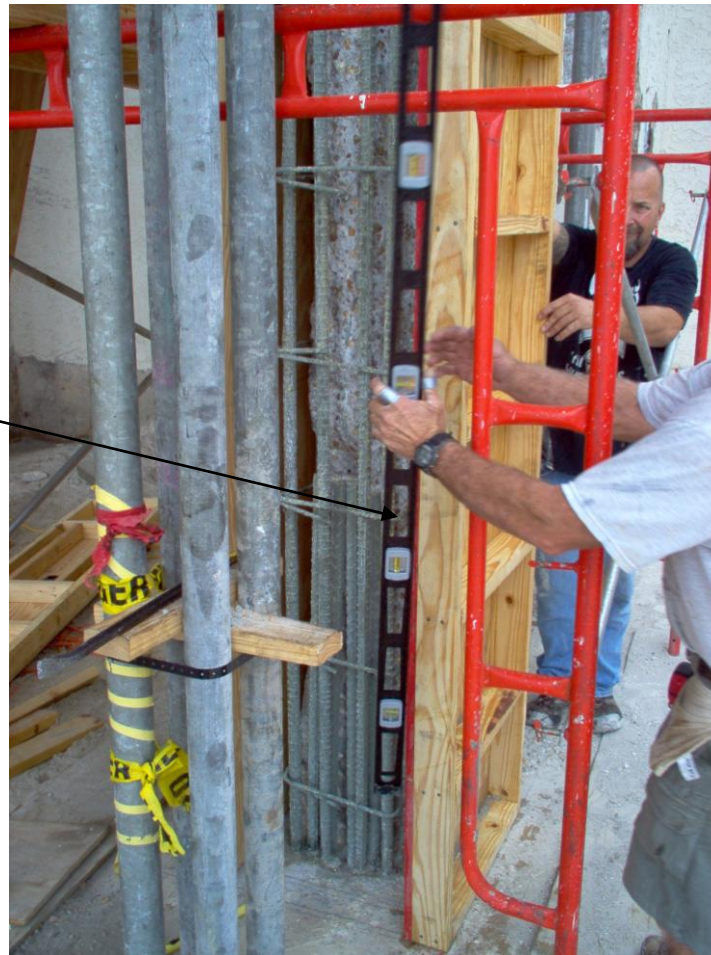
Forms being installed

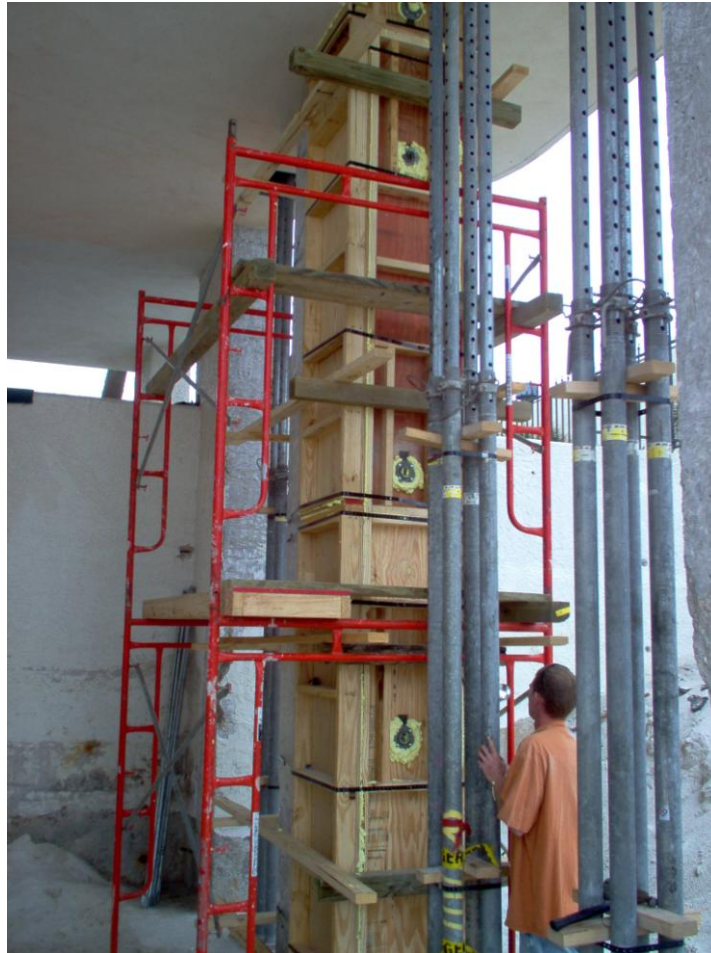
Banding is installed to support pressure grouting

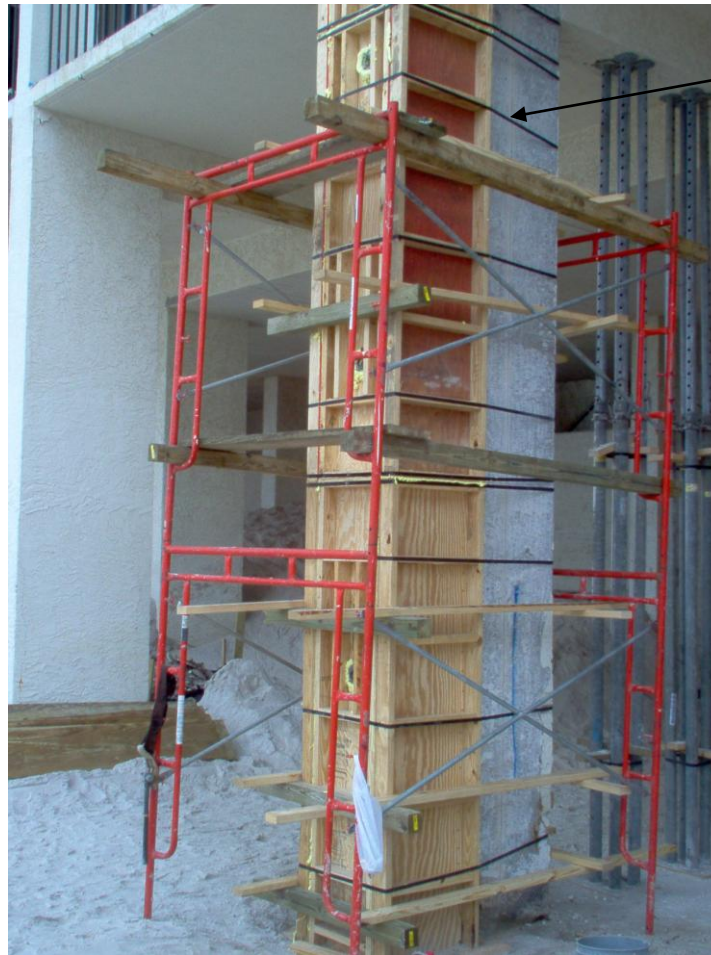
Metal banding

Pumping of 7000 PSI concrete with rust inhibitors, plasticizers and micro silica sand.

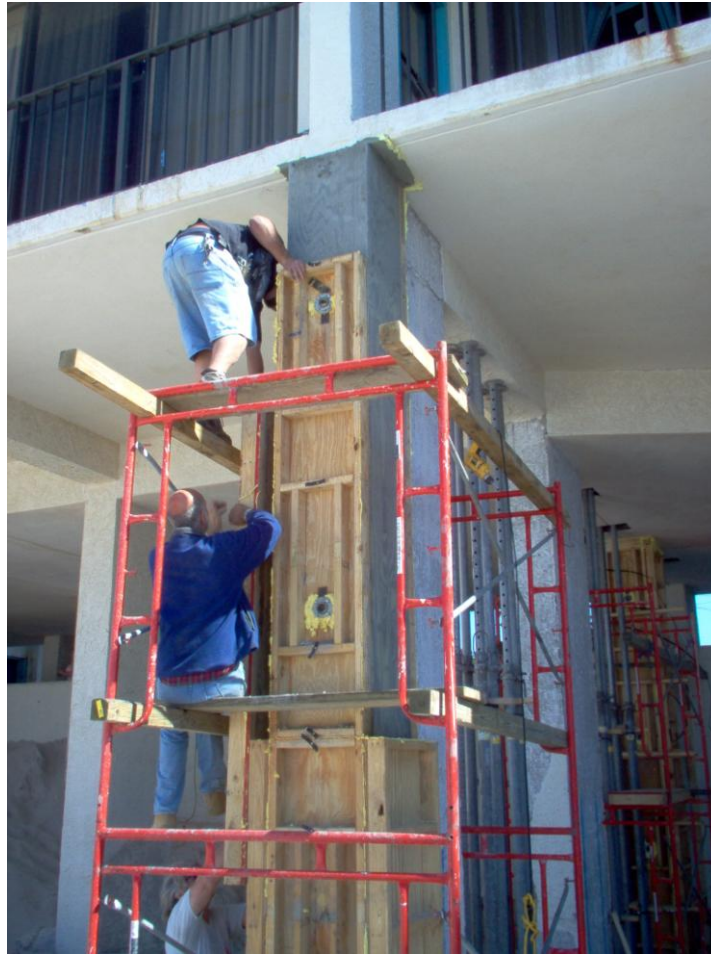
The column is encapsulated with 1 5/8" of new concrete, the wood grain is transferred to the concrete under pressure

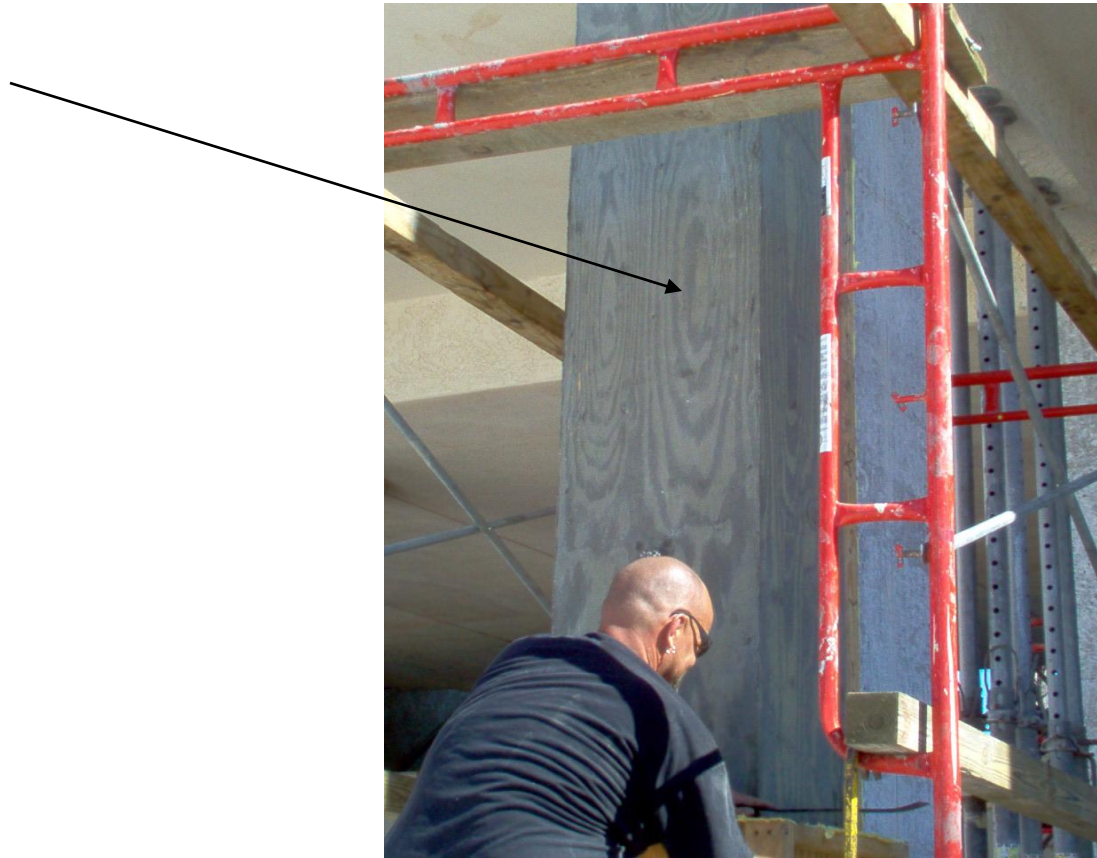
Stucco is applied over new concrete and then painted

Beam

1 5/8" new
concrete

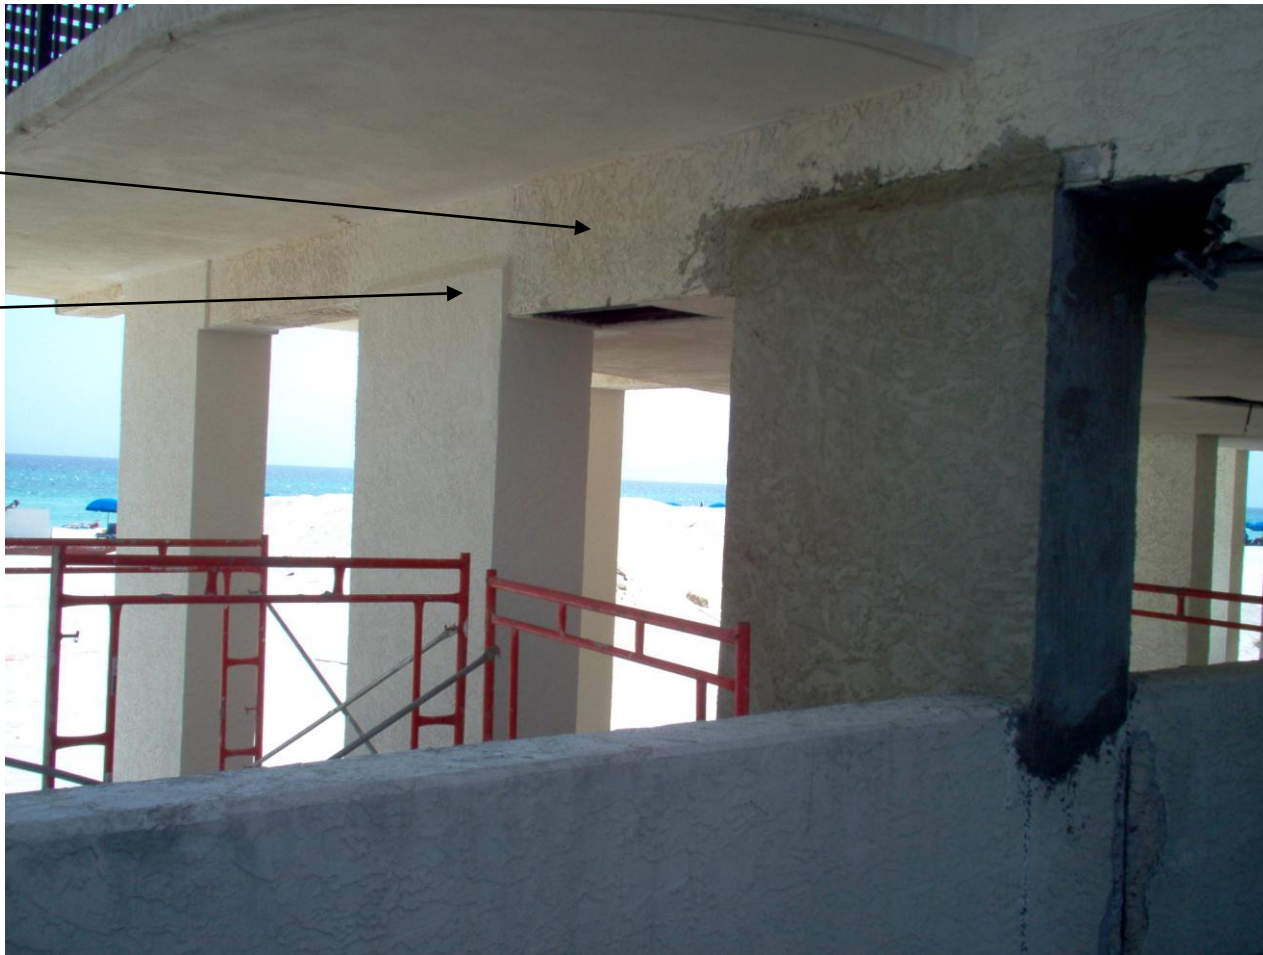
Replacing sand under building

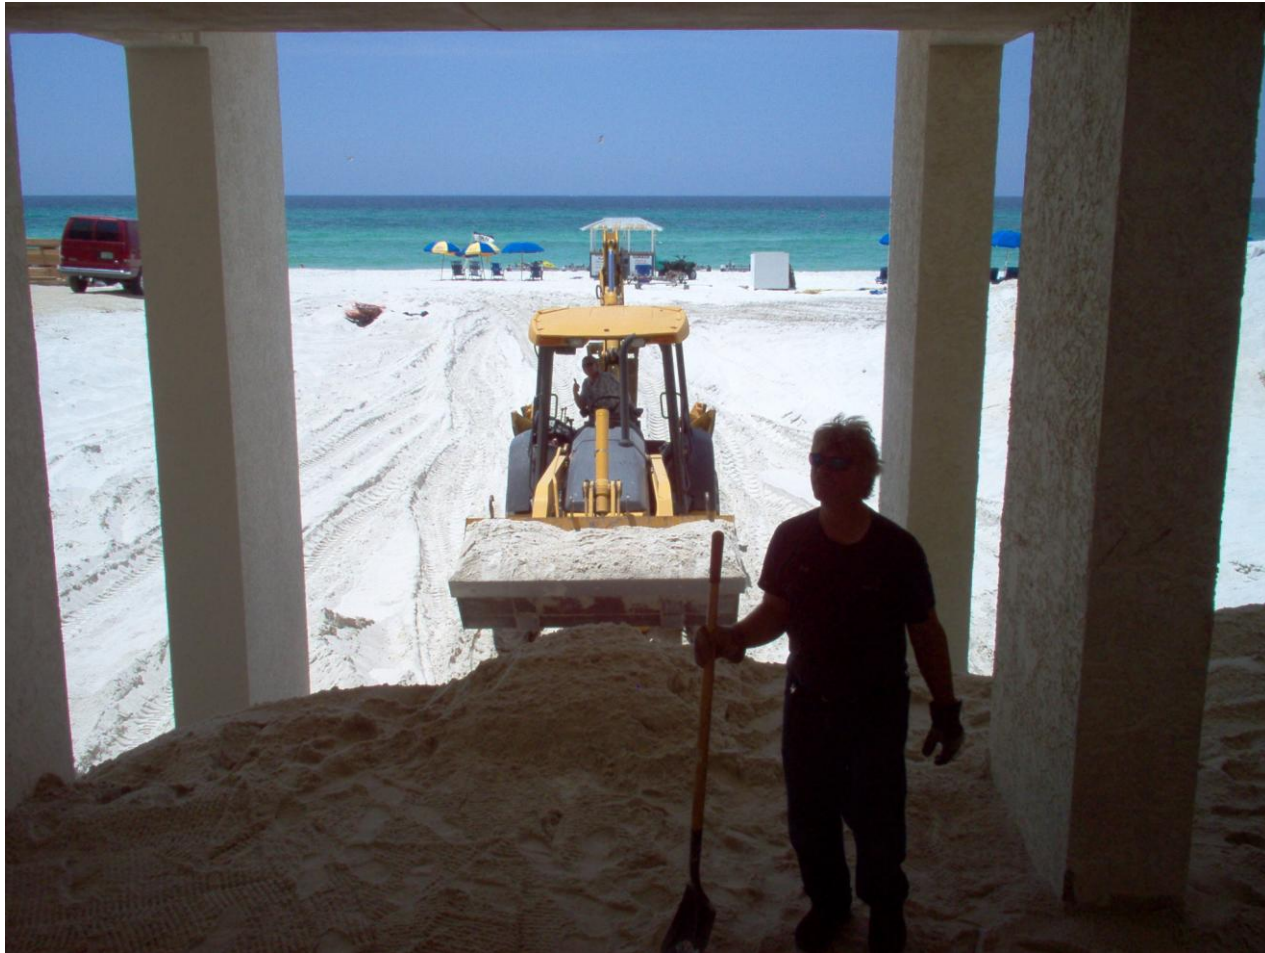
Final grading and cleaning
