Epoxy injection for water leaks in a pool

Beaches Construction Company

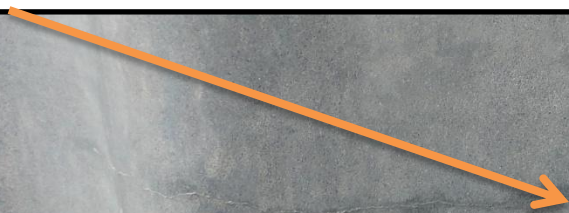
Hairline cracks inside of pool
concrete walls, damp with
moisture

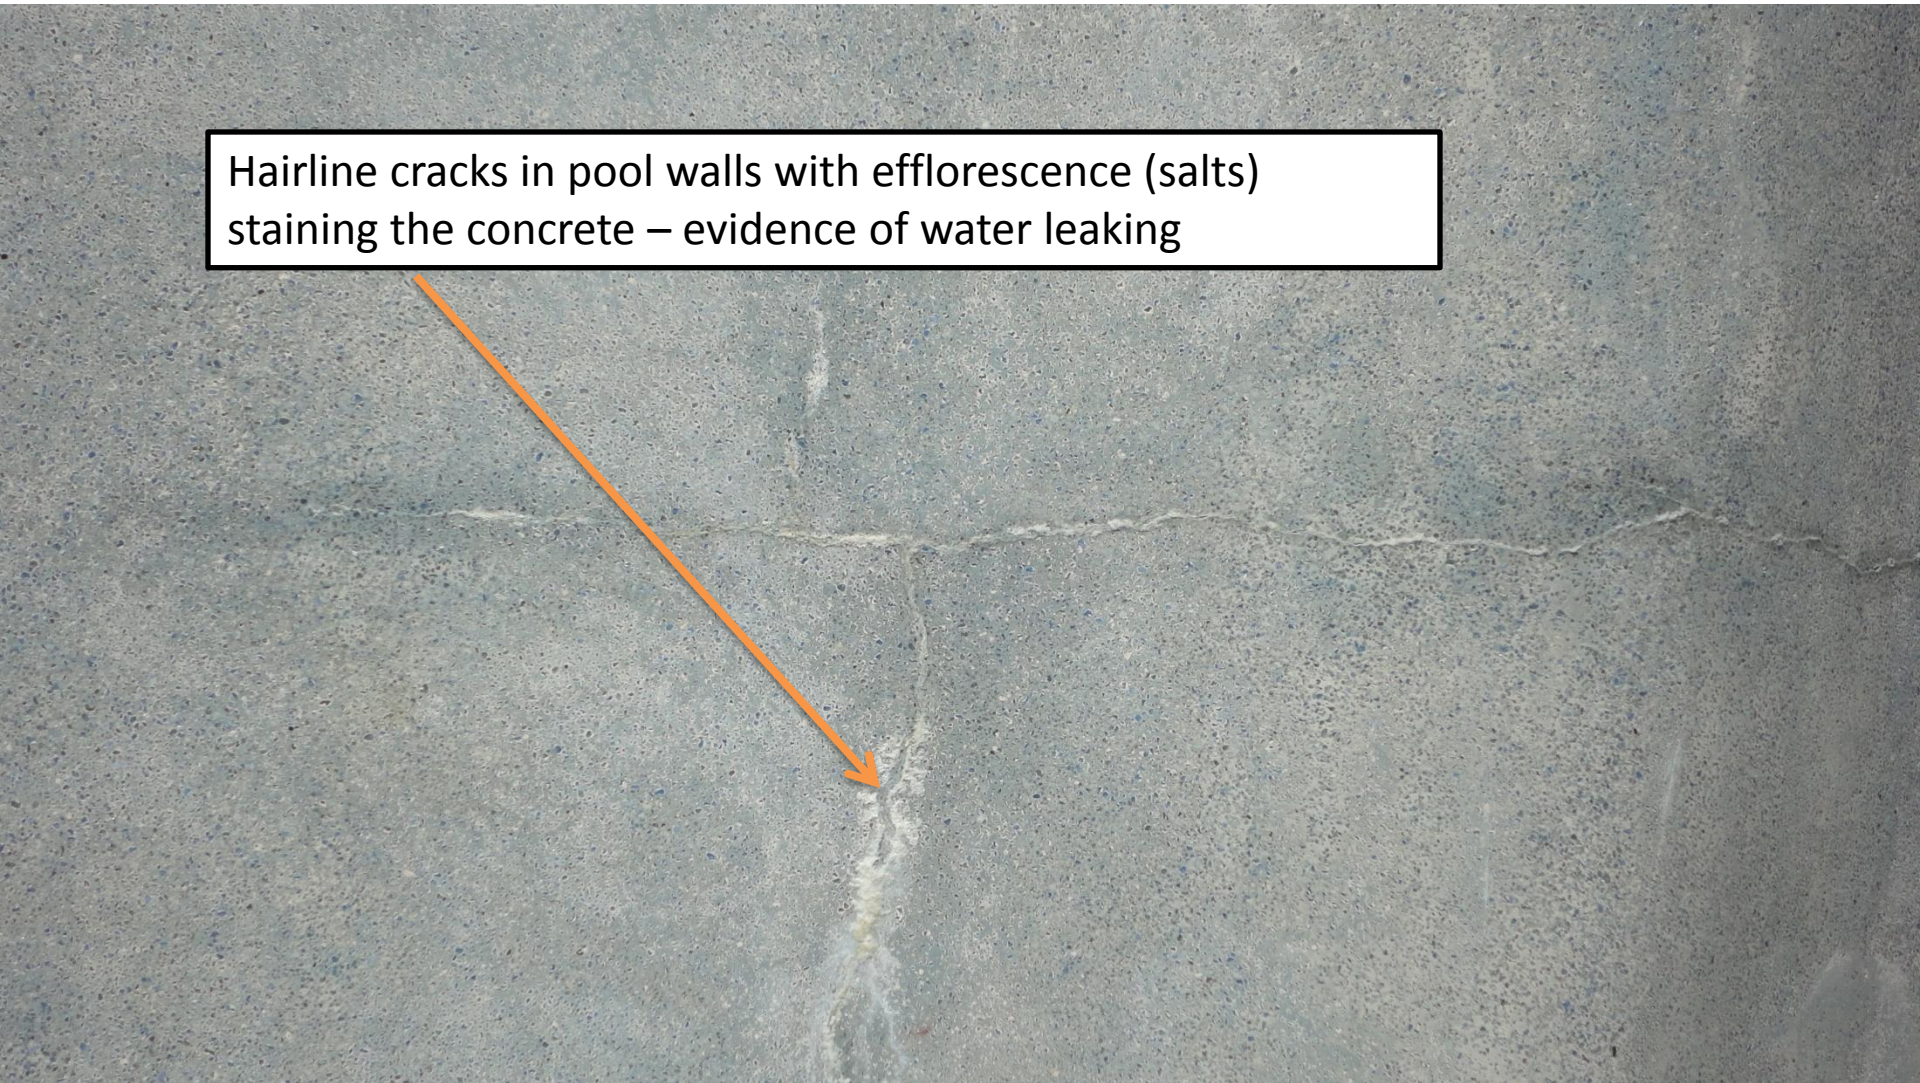
Hairline cracks in pool walls with efflorescence (salts) staining the concrete – evidence of water leaking

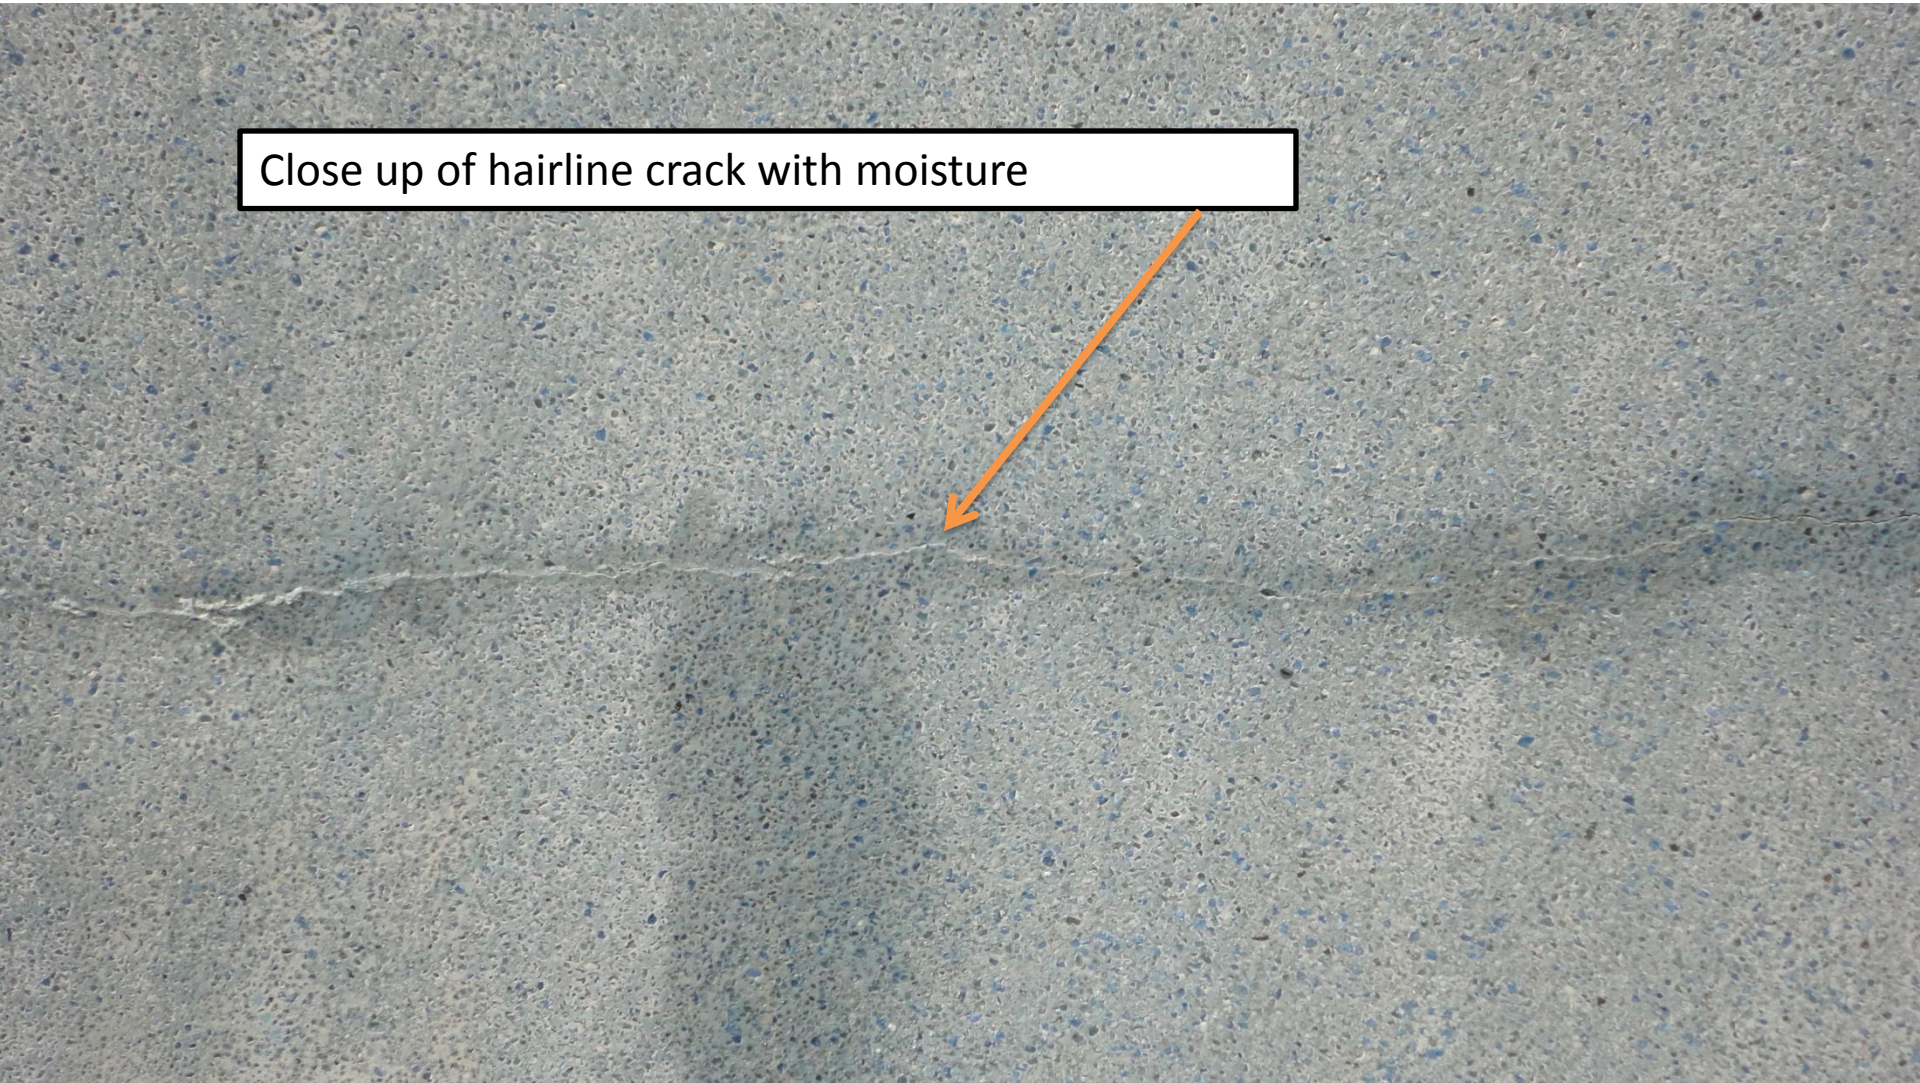
Close up of hairline crack with moisture

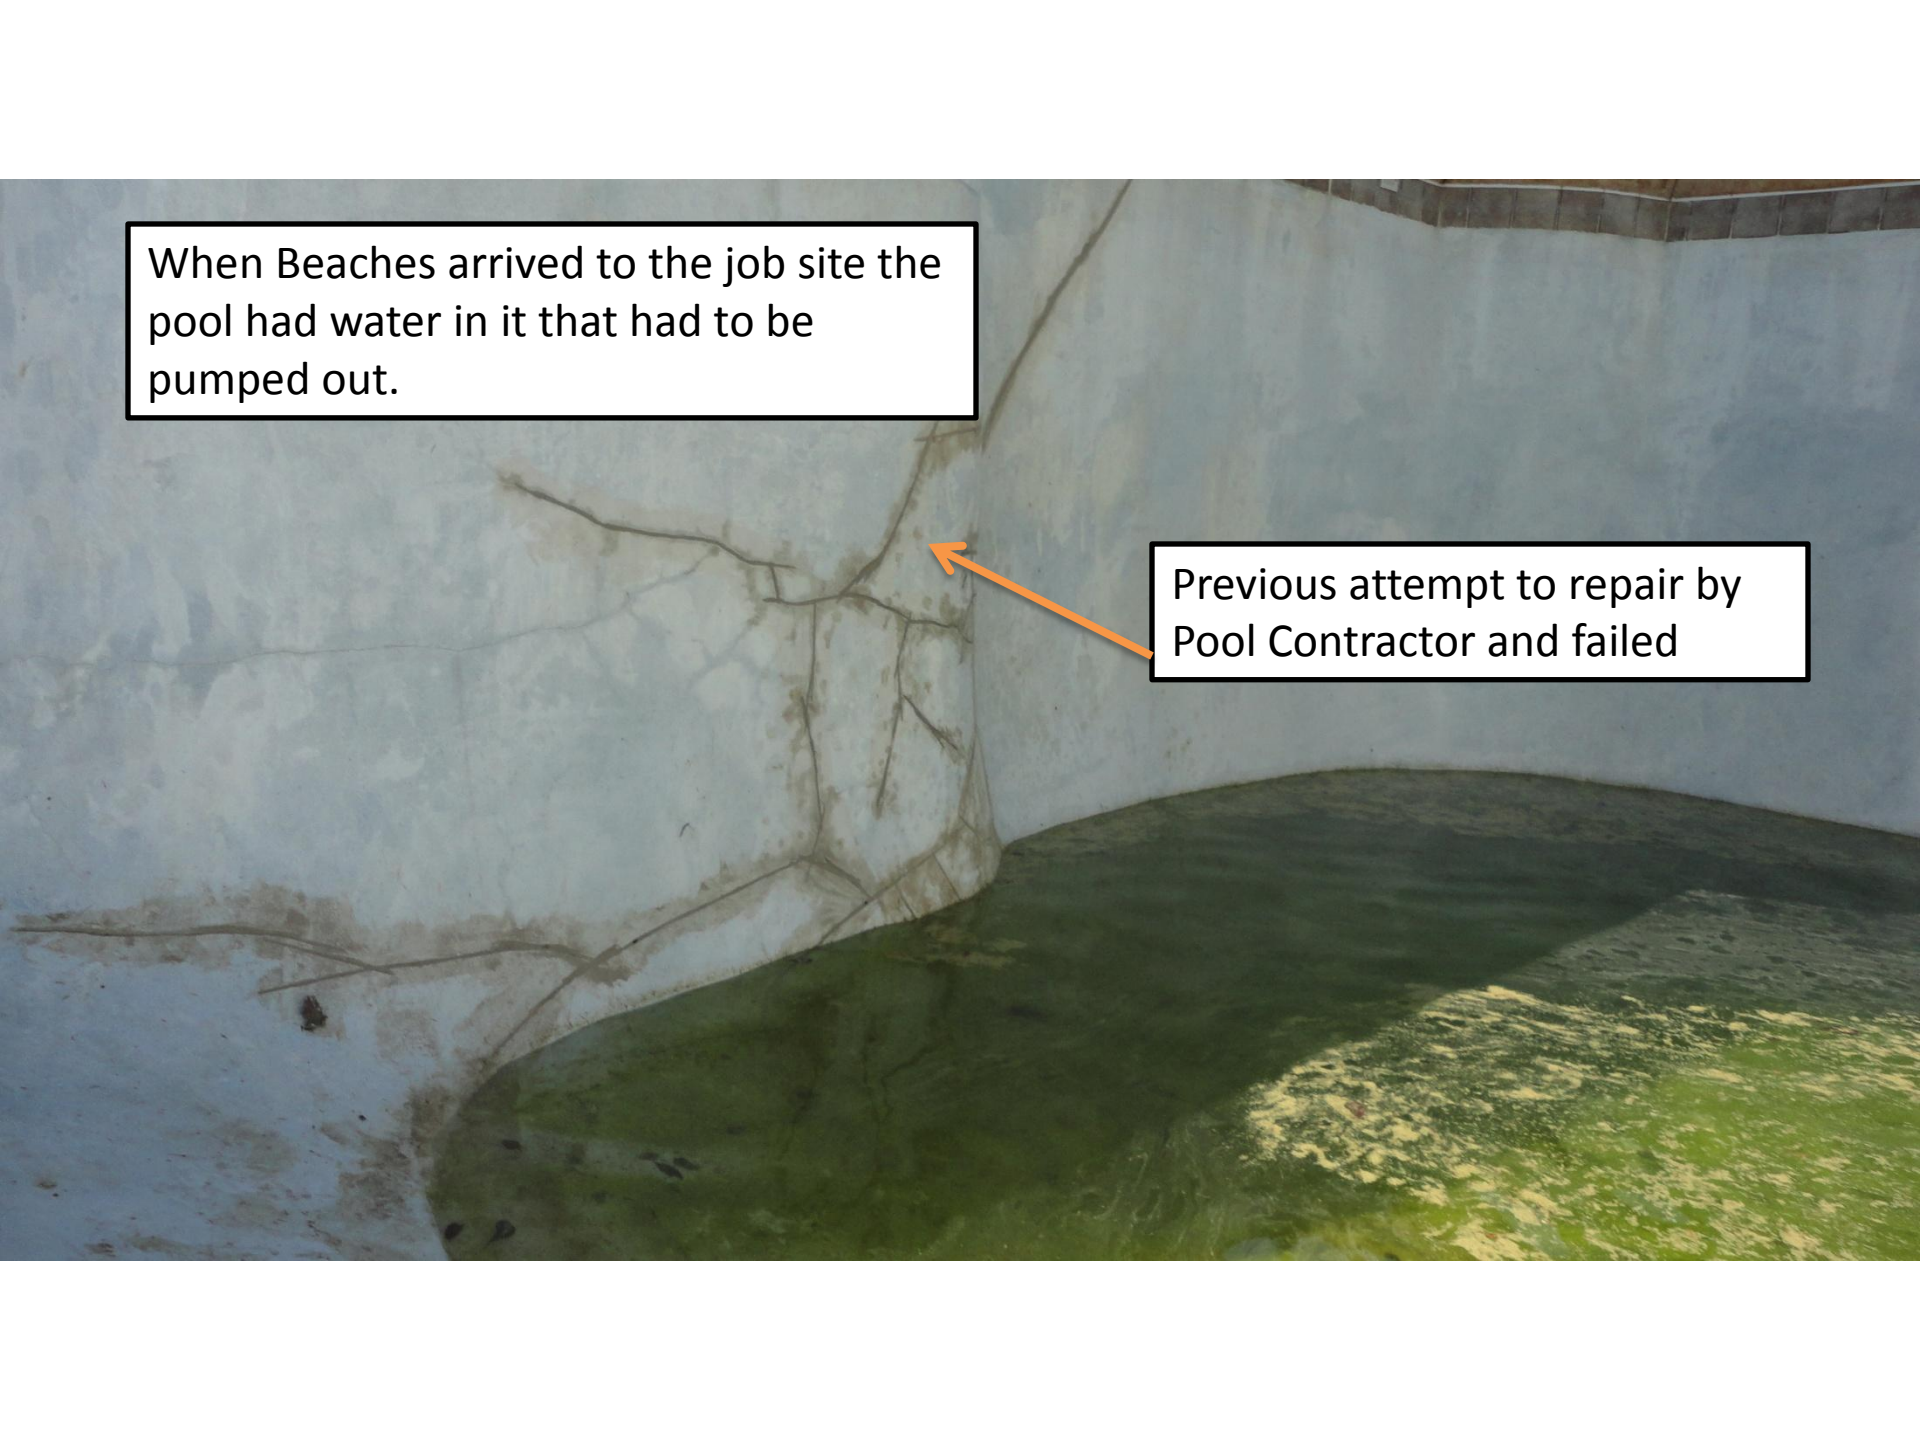
The image shows the interior of a swimming pool. The walls are a light, off-white color and show significant cracking and staining, particularly in the lower half. The floor is a dark green color, heavily covered with bright green algae. An orange arrow points from a text box on the right to a specific crack in the wall. Another text box is in the upper left corner.

When Beaches arrived to the job site the pool had water in it that had to be pumped out.

Previous attempt to repair by Pool Contractor and failed

When previous pool contractor tried to repair cracks they did not even chase all the cracks

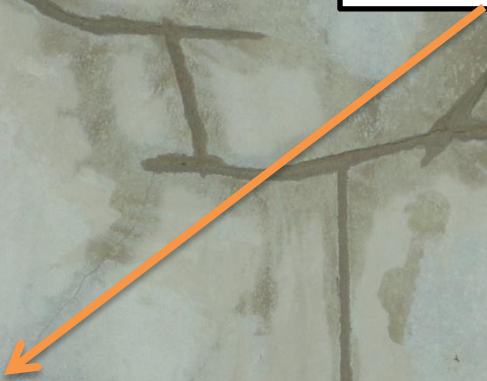
Another crack in the wall of the pool

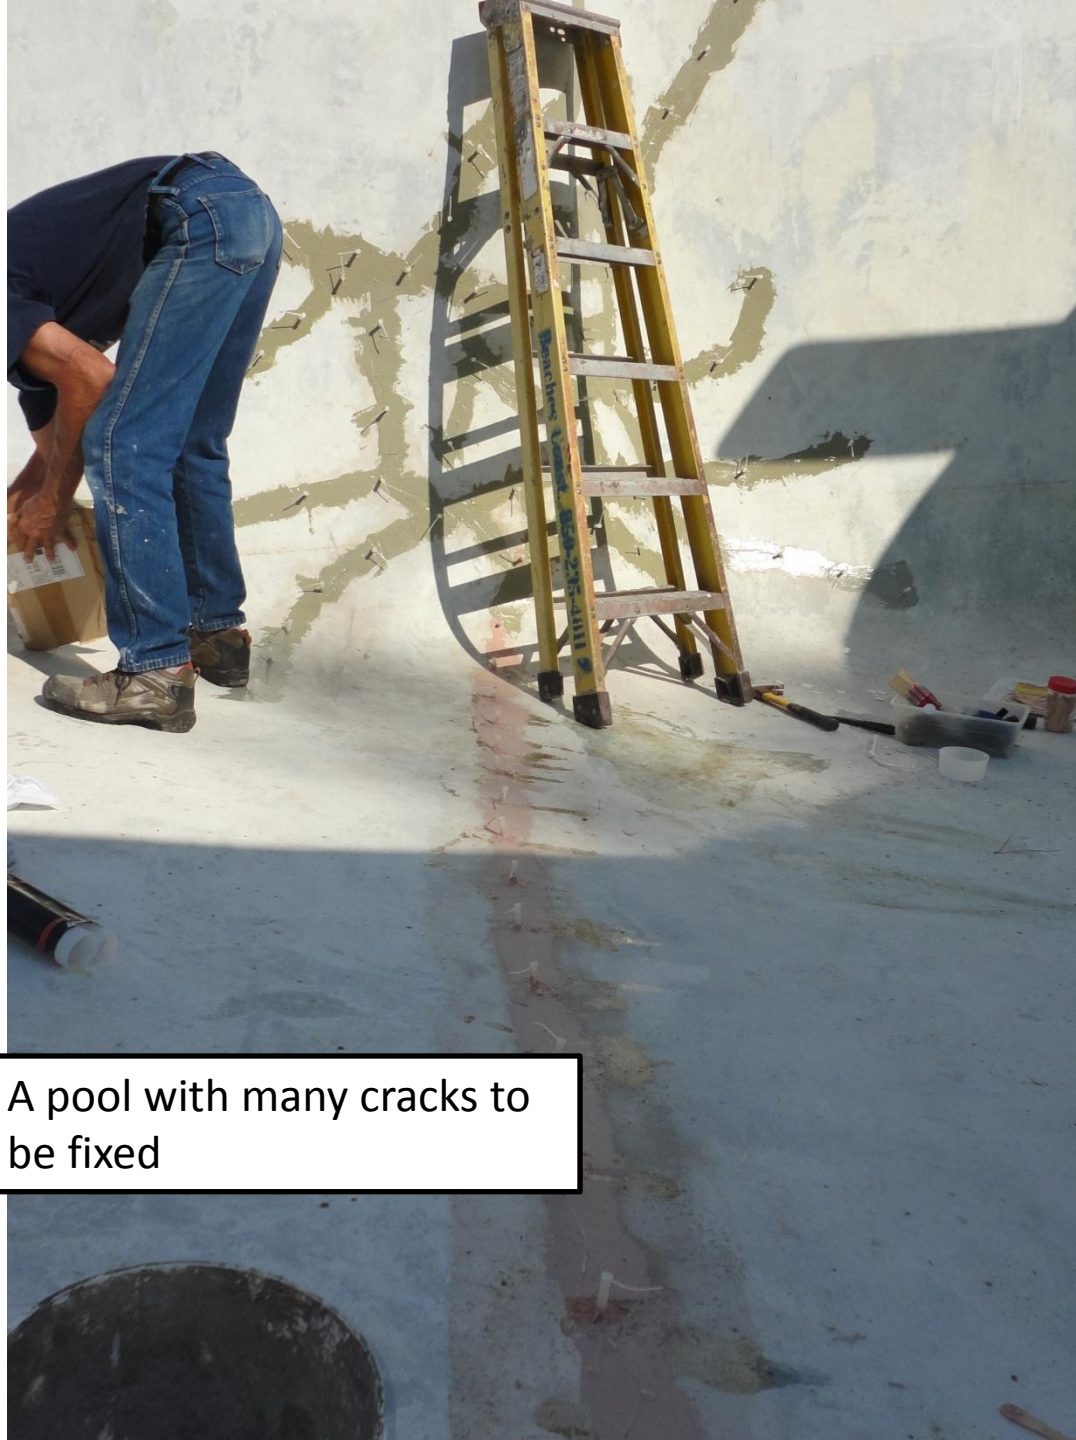
A pool with many cracks to be fixed

Drilling holes in the concrete to insert ports, spacing approx. every 8" along the crack and at every intersection of cracks

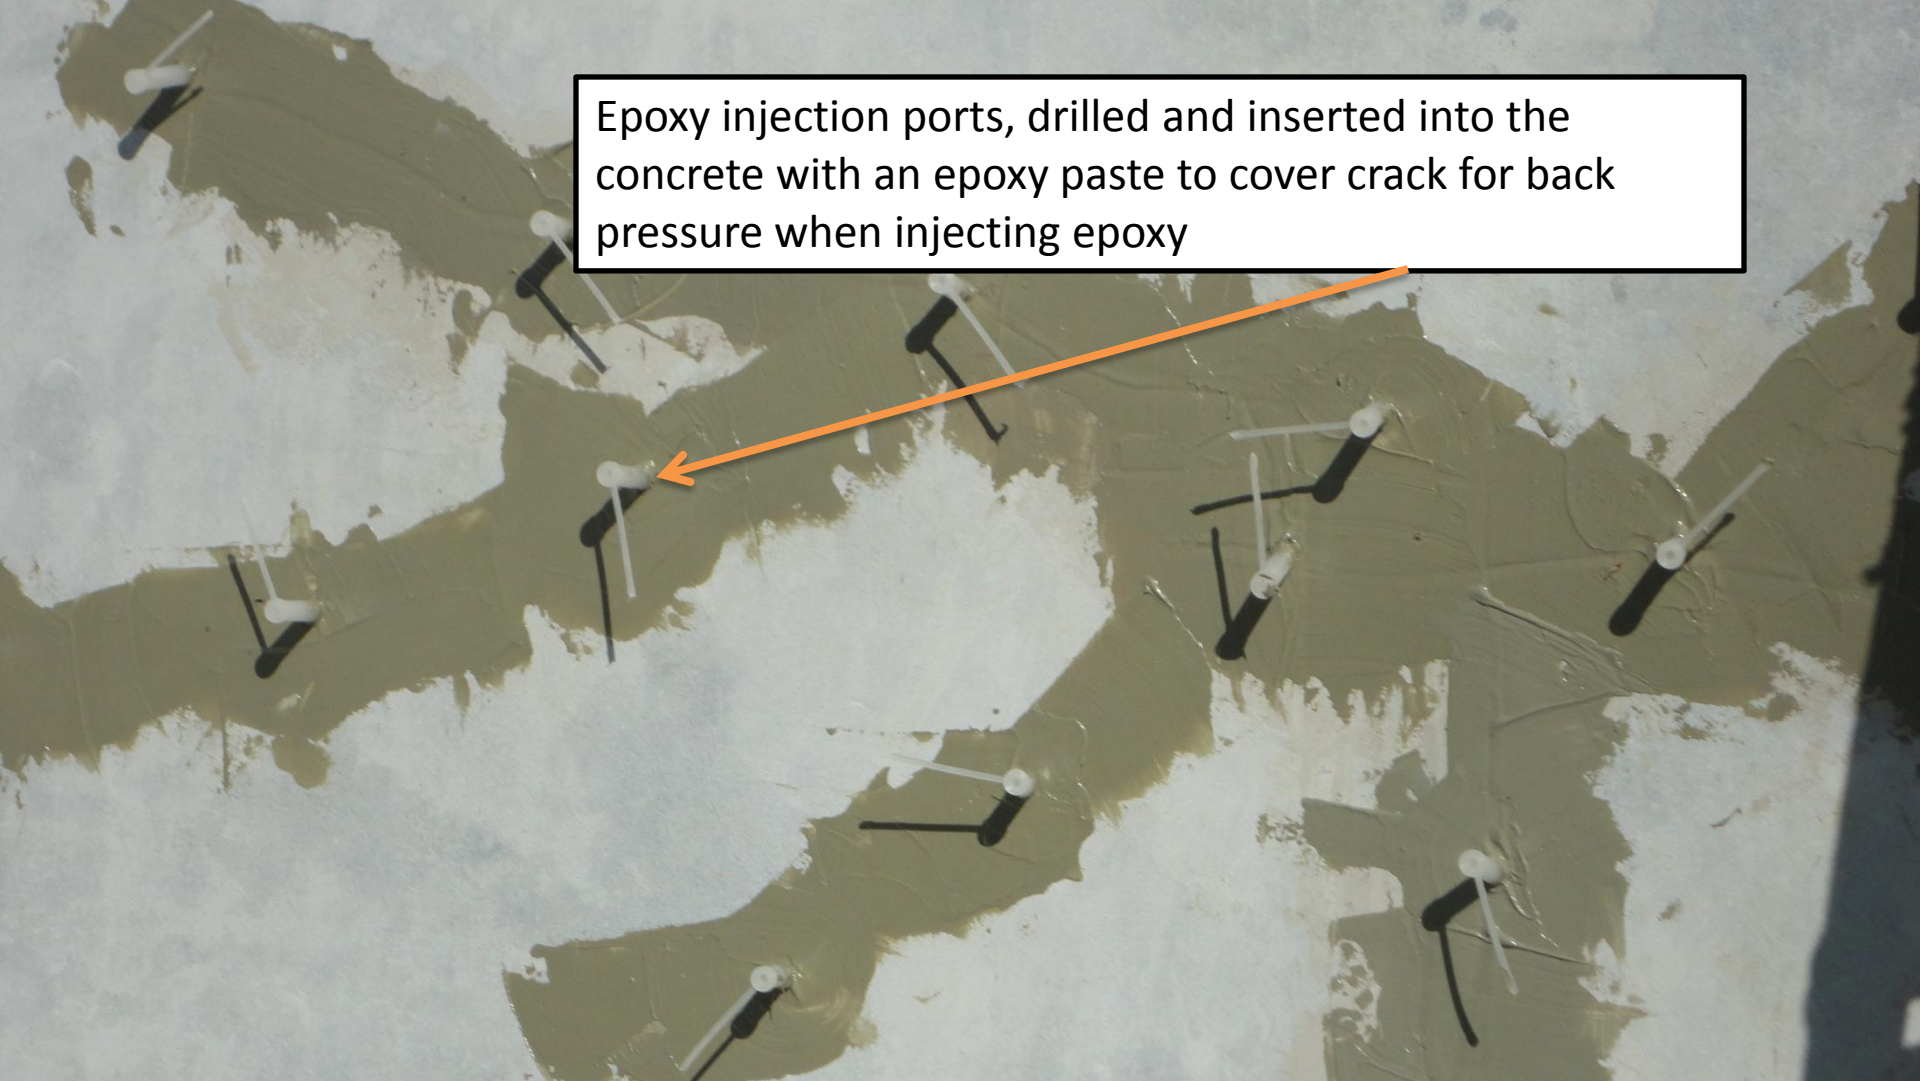
Epoxy injection ports, drilled and inserted into the concrete with an epoxy paste to cover crack for back pressure when injecting epoxy

1 complete epoxy kit was used at this port

3 epoxy kits plus were used at this port

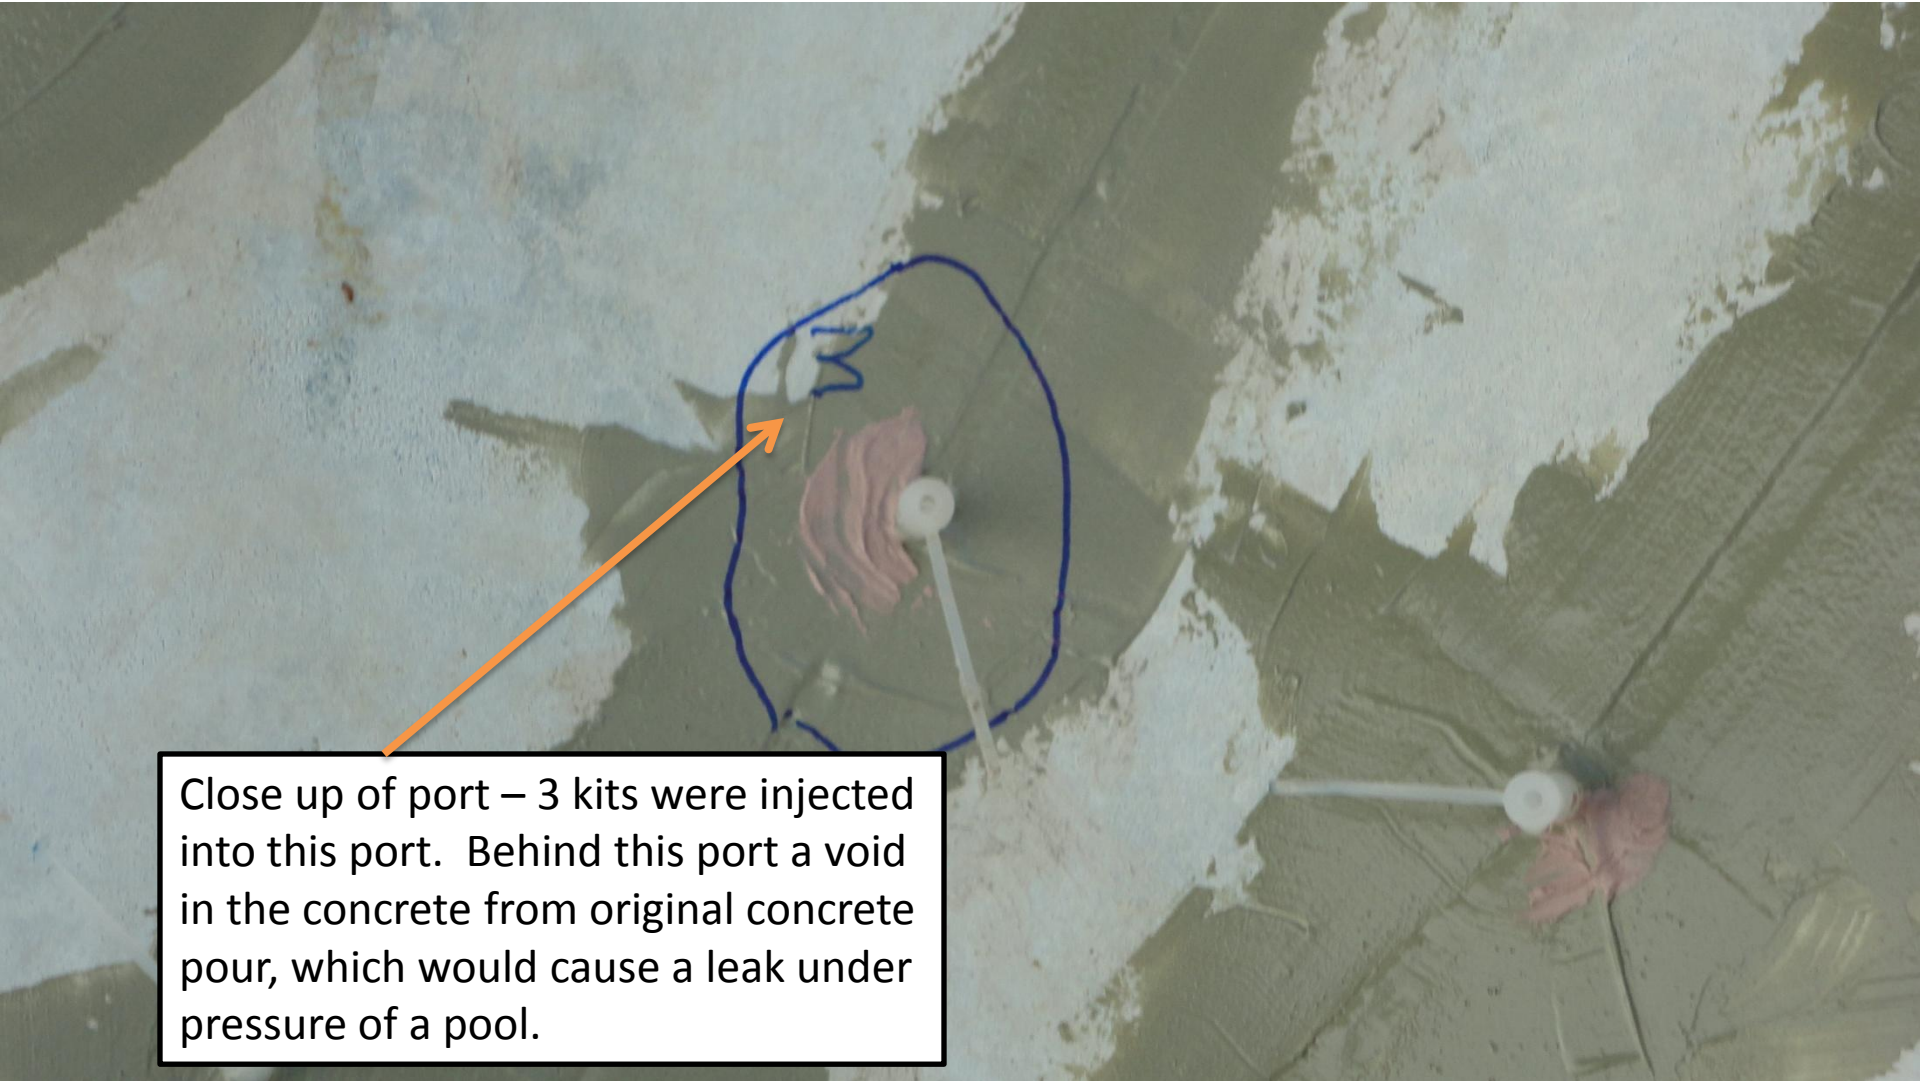
Close up of port – 3 kits were injected into this port. Behind this port a void in the concrete from original concrete pour, which would cause a leak under pressure of a pool.
